**PRELIMINARY ASSESSMENT/
VISUAL SITE INSPECTION**

**BARBER-COLMAN COMPANY
ROCKFORD, ILLINOIS**

ILD 005 145 958

FINAL REPORT

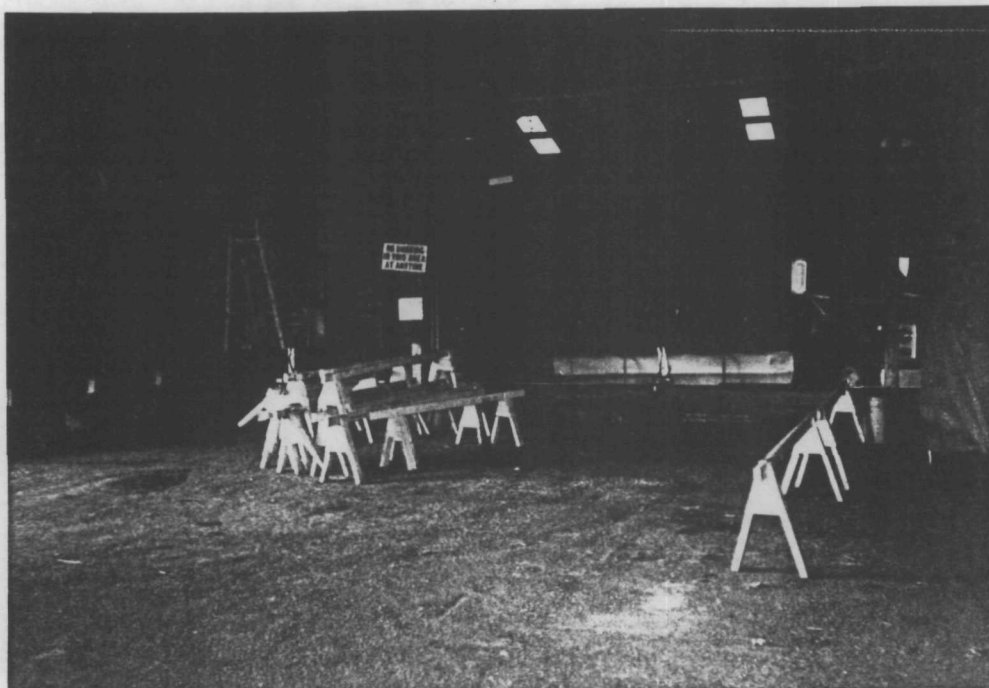
Photograph No. 1

Observations: This unit has been closed since 1988. No wastes were observed at this unit. The asphalt floor had no cracks and appeared visually sound.

Location: SWMU 1

Recommendations: Washwater samples for heavy metals were taken after closure and results were below the cleanup levels specified in the approved closure plan. Therefore, no further action is recommended at this time.

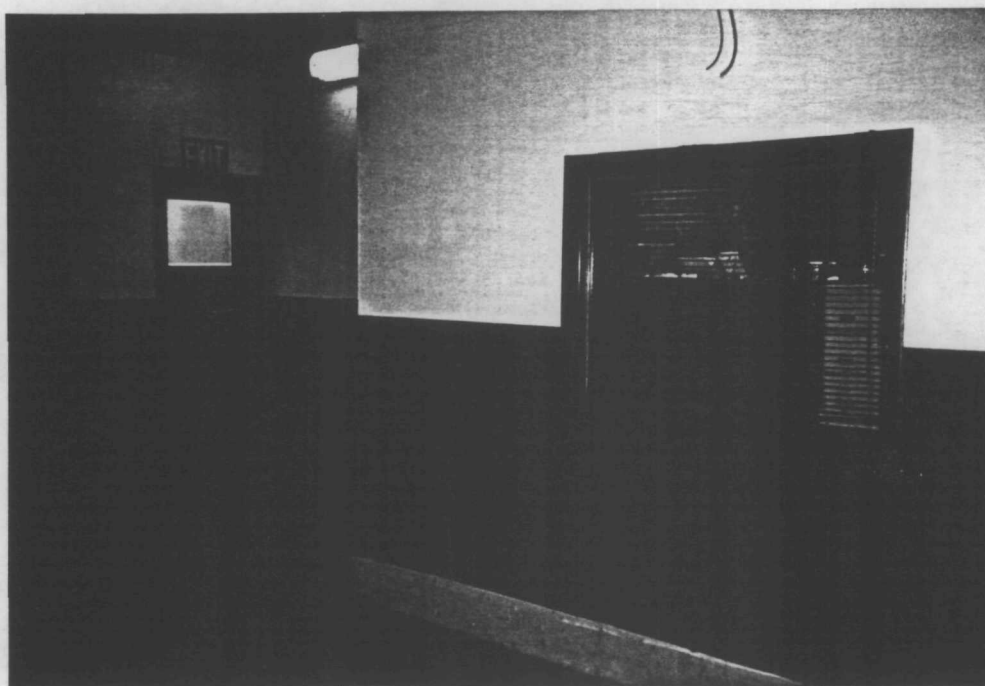
Photograph No. 2

Location: SWMU 2

Recommendations: Washwater samples for heavy metals were taken after closure and results were below the cleanup levels specified in the approved closure plan. Therefore, no further action is recommended at this time.

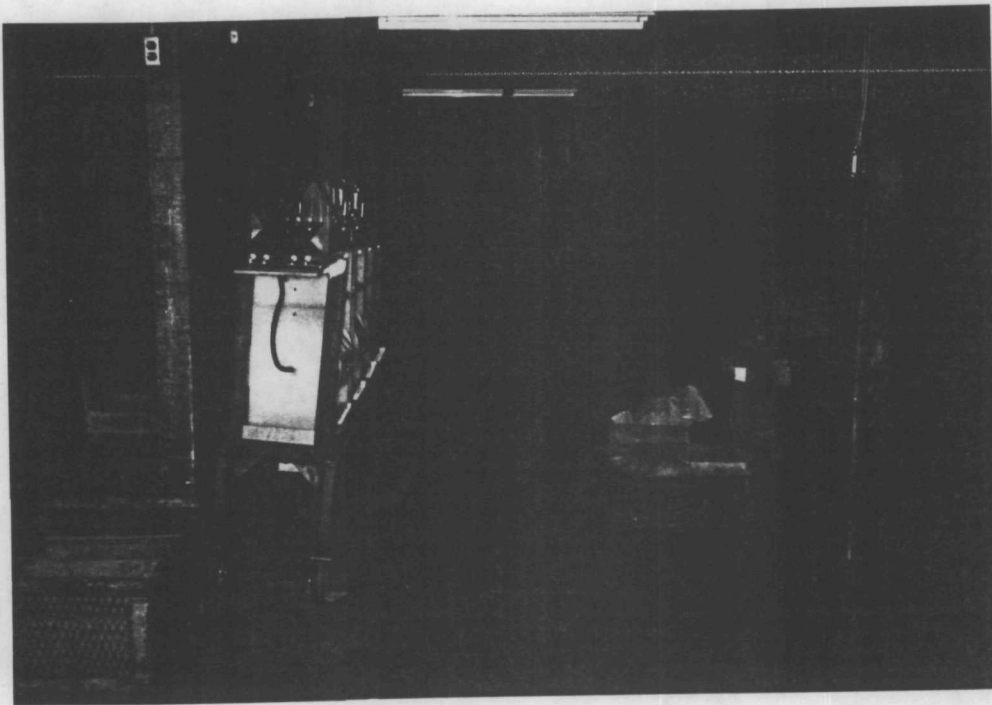
Photograph No. 3

Observations: This unit has been closed since 1988. No wastes were observed at this unit. The concrete floor appeared visually sound.

Location: SWMU 3

Recommendations: Washwater samples for heavy metals were taken after closure and results were below the cleanup levels specified in the approved closure plan. Therefore, no further action is recommended at this time.

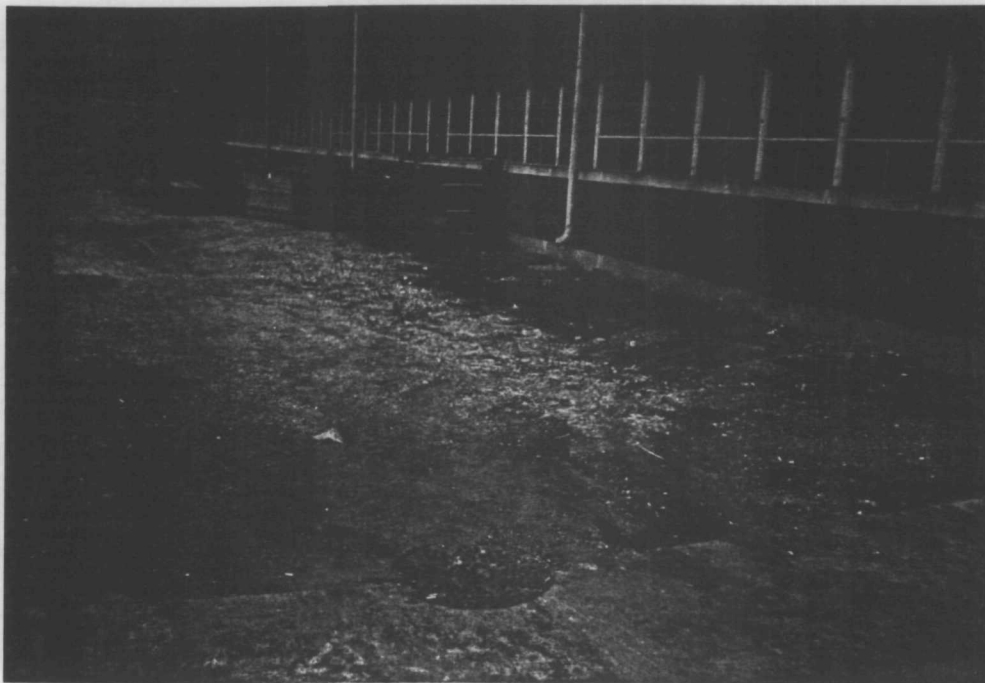
Photograph No. 4

Observations: This unit was used on 1 occasion to store 3 drums of waste. There were no wastes observed at the unit and no visual evidence of a release was observed.

Location: SWMU 4

Recommendations: Soil samples for heavy metals were taken after closure and results were below the cleanup levels specified in the approved closure plan. Therefore, no further action is recommended at this time.

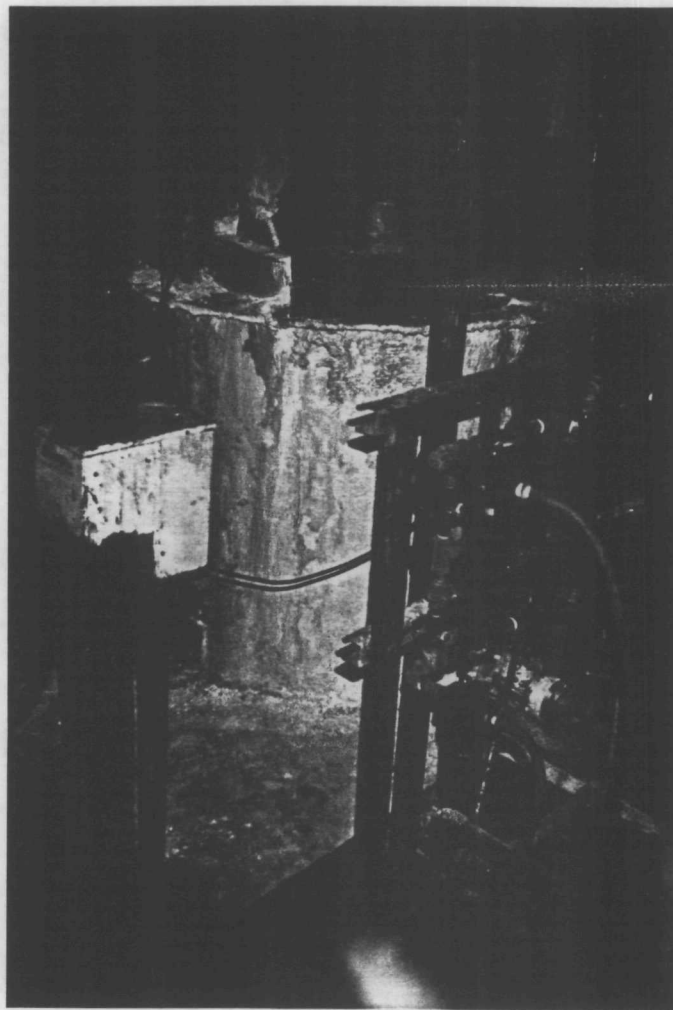
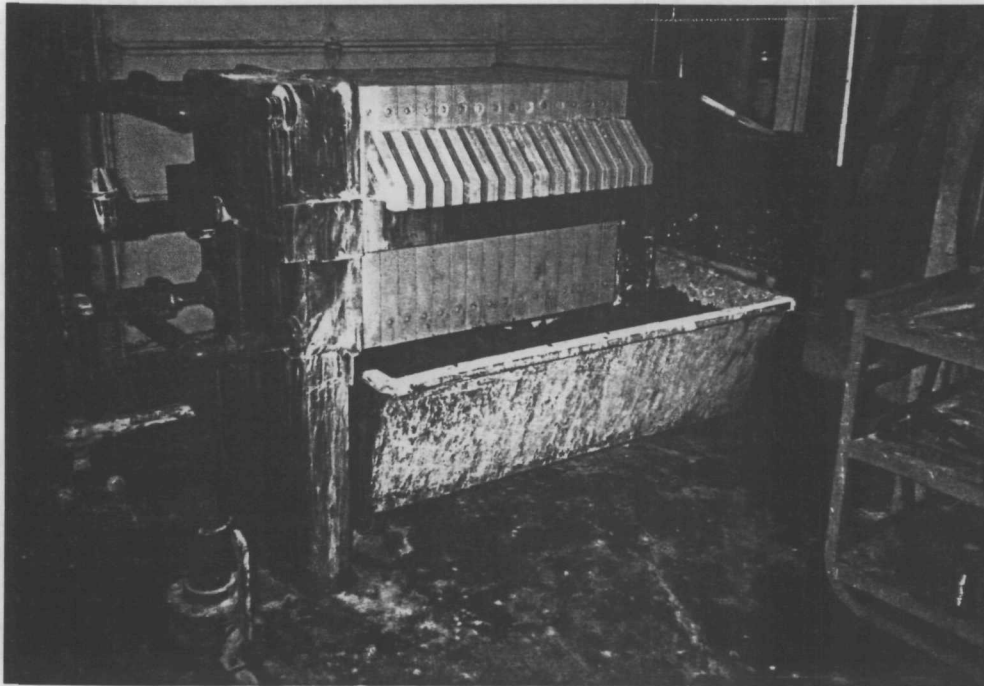
Photograph No. 5

Observations: The unit appears visually sound and no releases were observed during the VSI.

Location: SWMU 5

Recommendations: *No further action is recommended at this time.*

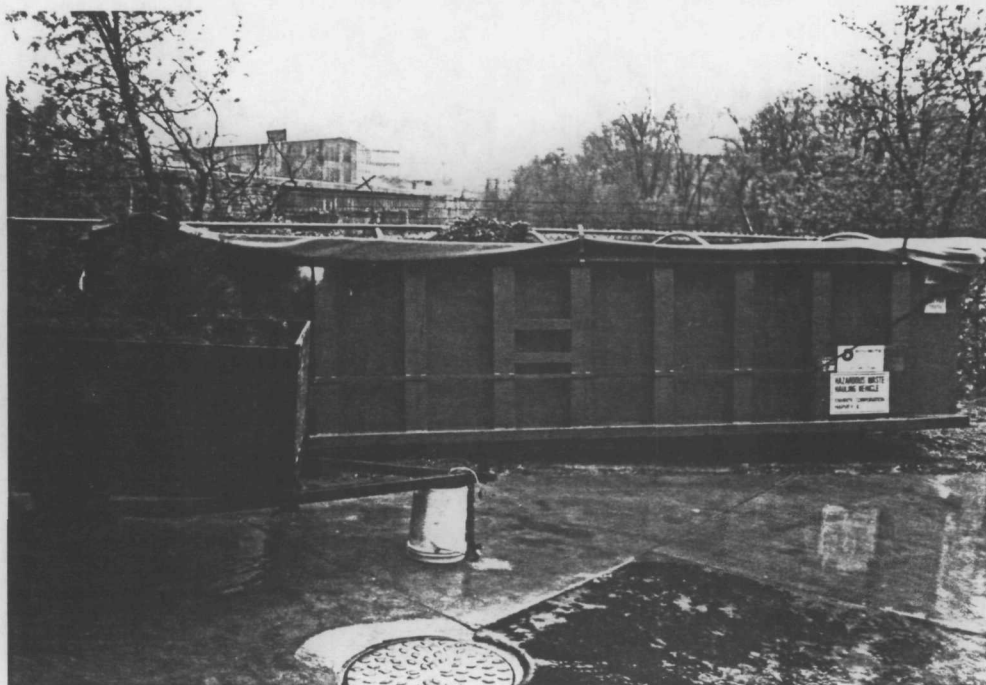
Photograph No. 7

Unit Description: This 20-cubic yard steel dumpster is located outside SWMU 5, separated by a wire fence along the bank of the Rock River. A plastic tarp covers the top of the unlined dumpster (photo 7). It is used for less than 90-day storage of hazardous wastes.

Observations: During the VSI, RAI noticed that the plastic tarp was not over the entire top of the dumpster. The unit was clearly marked as containing hazardous wastes.

Location: SWMU 6

Recommendations: *No further action is recommended at this time.*

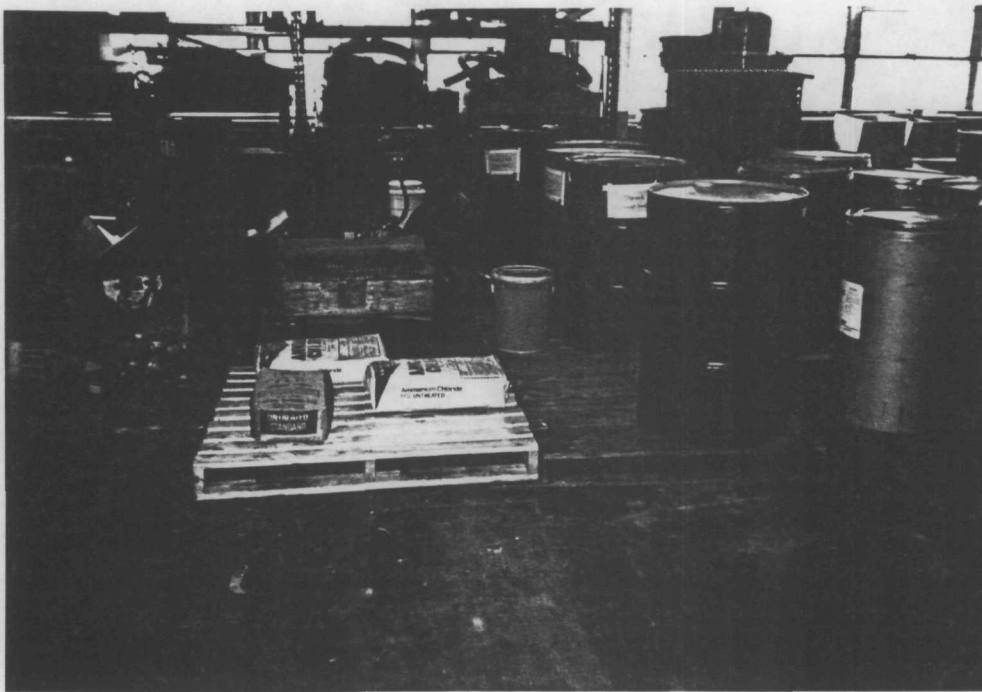
Photograph No. 8

Observations: During the VSI, no drums of TCA or cyanide salts were observed. The drums containing spent quench oil appear in sound condition and no evidence of a release was observed.

Description: This is the Waste Storage Area. No hazardous wastes were stored here during the VSI.

Recommendations: *No further action is recommended at this time.*

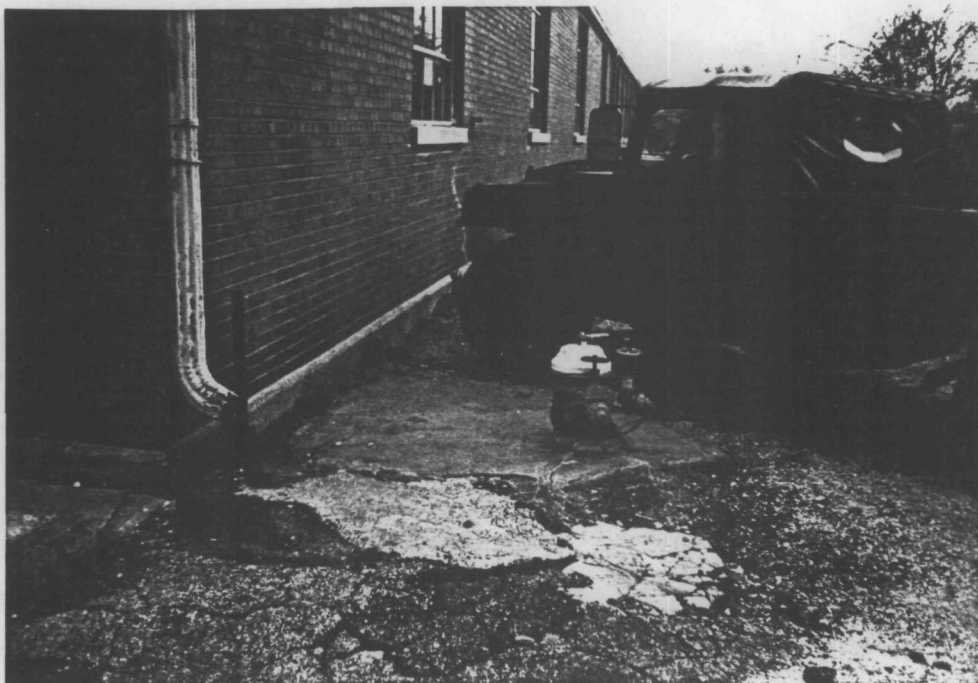
Photograph No. 9

History of Release: No releases have been documented at this unit. However, no soil samples have been taken to determine the presence of lead or corrosive contaminants.

Observations: No visual evidence of a release was observed.

Description: This is the Battery Storage Area. It has not been used since 1987.

Recommendations: The soil should be tested for possible lead and corrosive contamination. If the results are positive, then the extent of soil contamination should be defined and, if warranted, ground water should also be sampled.

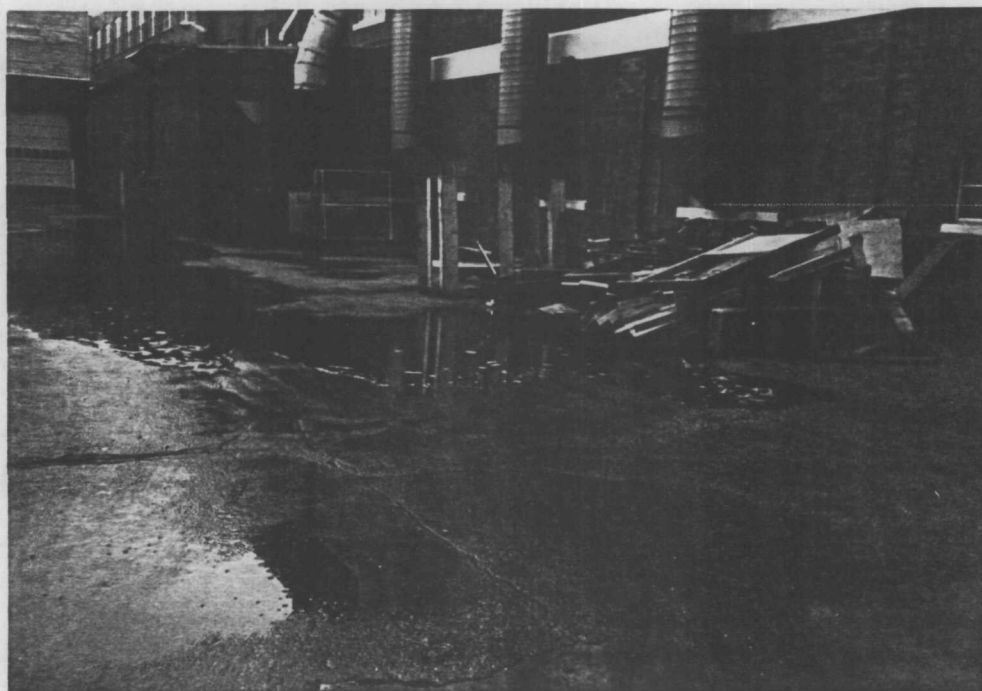
Photograph No. 10

Observations: During the VSI, no paint wastes were observed. The area is now used to hold general refuse.

Location: SWMU 9

Recommendations: Because the integrity of the containers and asphalt is unknown, it is possible that a release could have entered the soil through cracks and patches currently visible in the asphalt. Soil sampling should be conducted to determine the presence of contaminants.

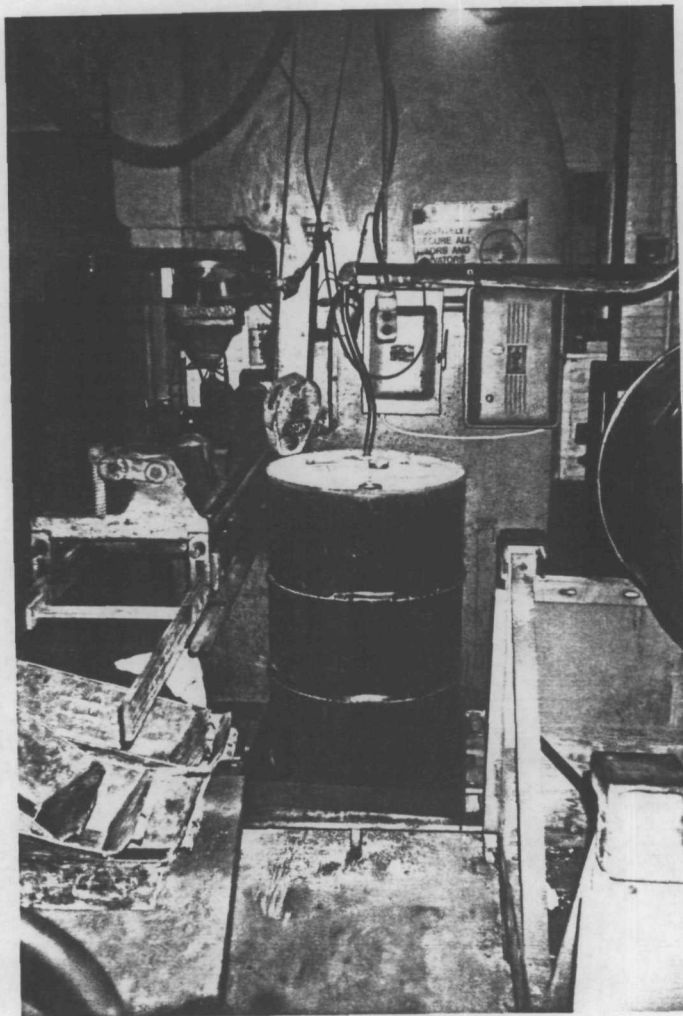
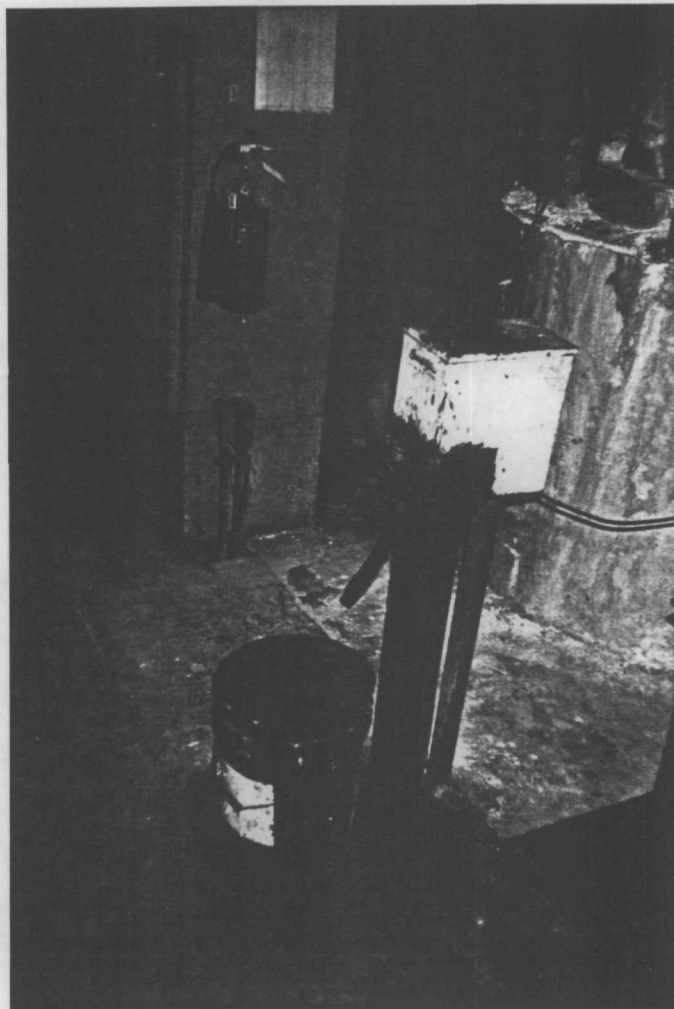
Photograph No. 11

History of Release: No releases have been documented from this unit. Cyanide salts were observed by RAI personnel on the floor around the cyanide drum.

Observations: The containers appear old and are rusted in spots. Cyanide salts were observed on the floor around the drum during the VSI.

Location: SWMU 10

Recommendations: No further action is recommended at this time.

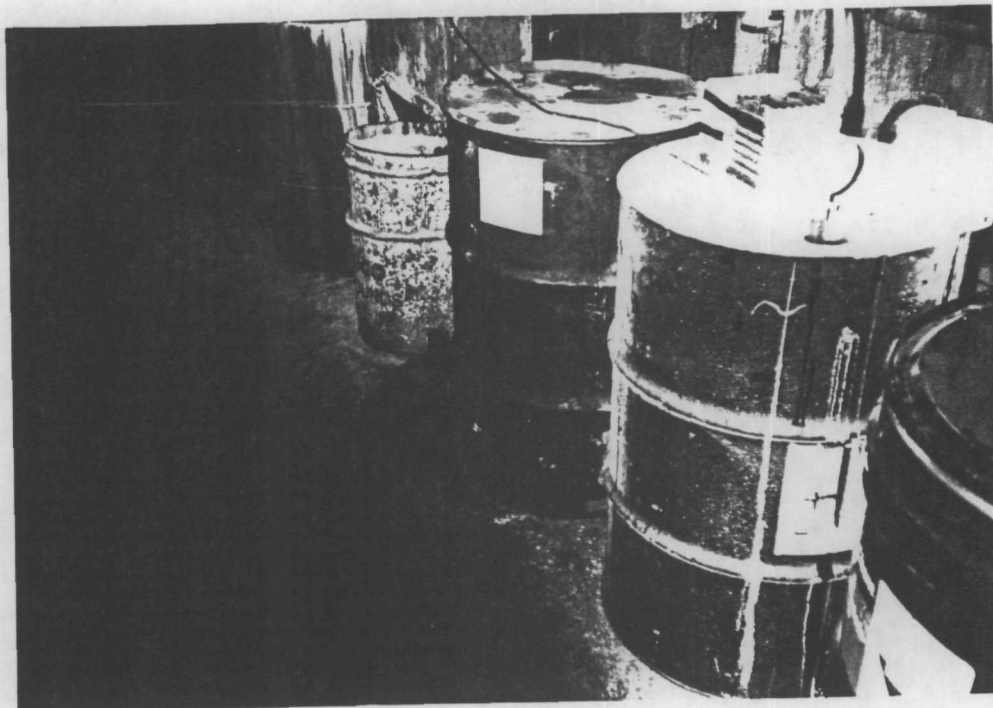
Photograph No. 13

Description: The 55-gallon drum marked "Hazardous Waste" contains non-hazardous quench oil. Wastes from the 5-gallon bucket (photo 12) are transferred into this drum.

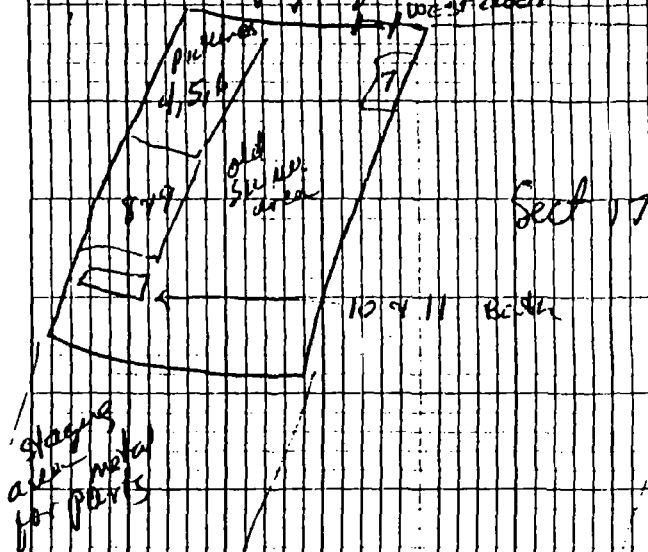
10, 11

Temp. Plating Bath
staging area for metal
parts, also has the temporary
plating bath

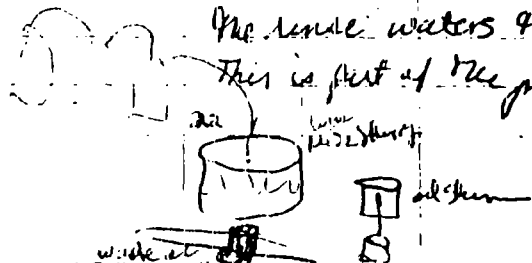
23

Oil waste is in a 55-gal barrel
marked Hazard Waste. When it
is full it is removed for
disposal. This barrel is directly
across from the oil skimmer
in the pretreatment area
